FLIGHT *fax*

Army Aviation Composite Risk Management Information

**"System Safety:
For the Soldier"**

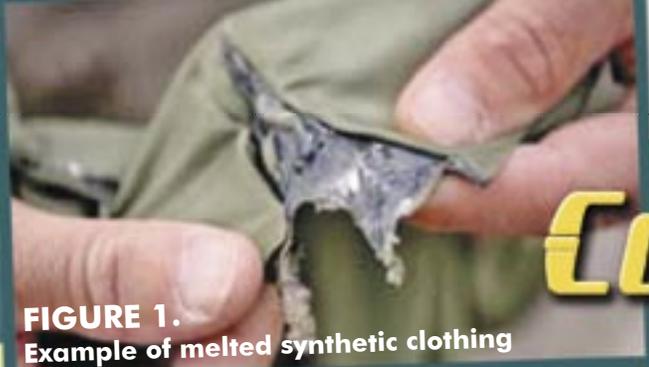
FIGURE 1.
Example of melted synthetic clothing

- **Polyester underclothing manufactured by companies such as Under Armour®, CoolMax®, and Nike®.** Undergarments manufactured from synthetics such as polyester or acrylic can melt and fuse to skin when exposed to high temperatures and flames (figure 1). This warning also applies to novelty undergarments such as underwear with cartoon characters, jokes, etc. Burns from these garments melting against your skin can be disfiguring and even fatal. Military doctors have reported an increased difficulty in burn-related wound treatment from the necessity of removing melted clothing from the wound. Natural fibers such as cotton, wool, or Nomex® are the best materials for aviation undergarment use.

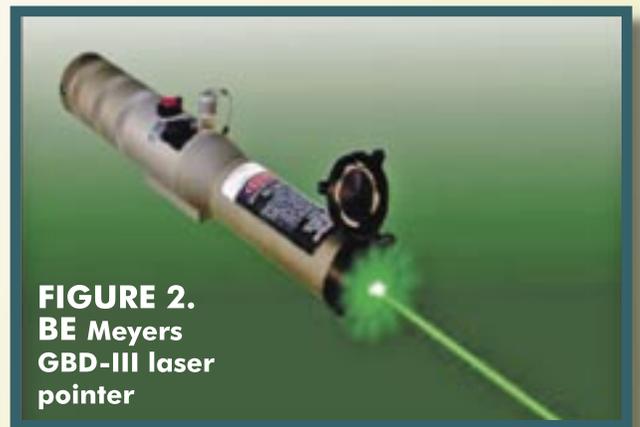
FIGURE 2.
BE Meyers
GBD-III laser
pointer

compromise the safety of the crew during night missions. There are a wide variety of lasers available, ranging from powerful military pointers (figure 2) to lower-powered, presentation-style pointers (figure 3).

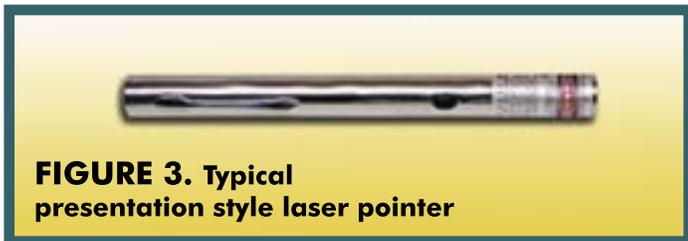
FIGURE 3. Typical presentation style laser pointer

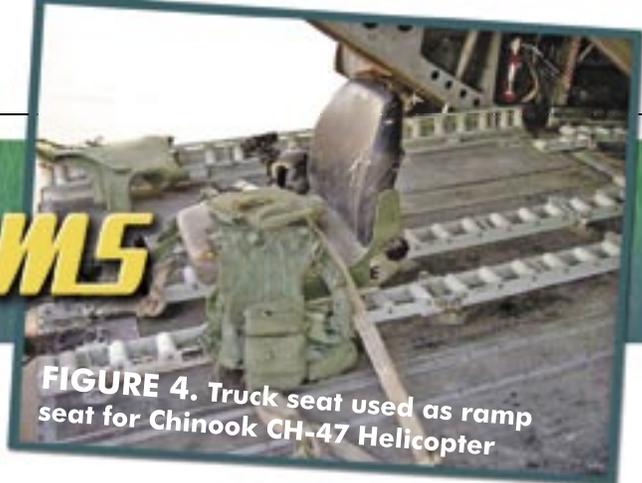
FIGURE 4. Truck seat used as ramp seat for Chinook CH-47 Helicopter

(figure 4) as door gunner and ramp seats. Fabricated gun mounts may not take into consideration appropriate traverse and elevation limits, allowing the operator to inadvertently shoot the rotor blades. Automobile seats are not designed to the same crashworthiness standards of aircraft seats and may pose a real health hazard in a crash. Something as simple as modifying individual flight crew seat cushions could result in serious injury during an emergency.

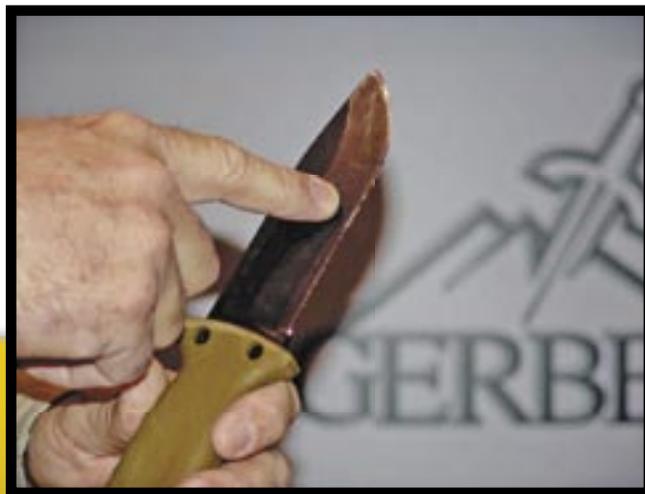
▲ **Figure 3.** Gerber Legendary Blades LMF II with finger pointing to burns in blade just above serrations.

SFC Johnson and his spotter were able to return home and share this story. The only damage to the knife was some slight blade edge burns (figures 3 and 4). It should be noted cutting charged electrical wires is potentially fatal and should not be attempted. As SFC Johnson stated, "I wasn't exactly thrilled about having to cut hot lines, but in battle, you do what you have to do."

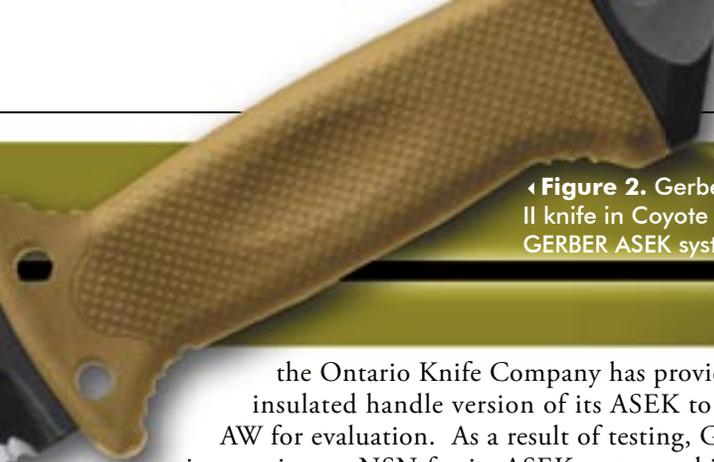
◀ **Figure 2.** Gerber P.N. 22-01400 LMF II knife in Coyote Brown and part of the GERBER ASEK system tested.

In May 2005, Gerber Legendary Blades entered into a Cooperative Research and Development Agreement (CRDA) with the U.S. Army Aeromedical Research Laboratory (USAARL). The CRDA was to test and evaluate the Gerber LMF II knife (figure 2) against the Army-issue ASEK produced by Ontario Knife Company for the purpose of determining whether the Gerber knife met the same standards as outlined in the ASEK ORD. Testing and evaluation was conducted, and a report was published detailing the results.
